# THE IMPORTANCE OF QUALITY FOR OPTICAL TAPS

### WHITE PAPER

Published at Cubro, 2025

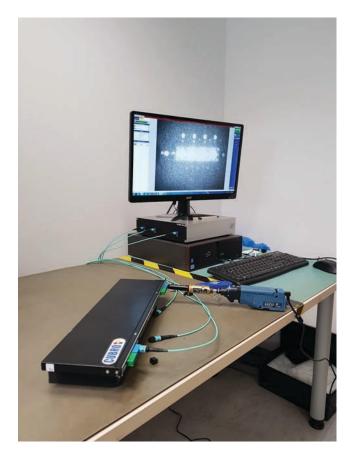
Cubro has developed a proprietary measurement device (1), that can measure up to 4 fiber pairs simultaneously, using all bandwidth speeds and all wavelength frequencies. This measurement method is not only very fast but produces repeatable results on each link; this is not often the case with standard optical power meters. The reason for this is that optical power meters are normally designed to measure longer optical fibers and not those of a very short distance.

The second key process for quality assurance is to visually inspect every connector for any contaminants or defects. We employ a fiber microscope (2) to accomplish this task. We even save a photo of each connector in a database for later reference and analysis in case a customer experiences an issue.

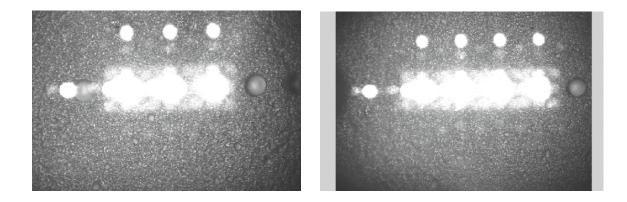
A visual inspection is also critical to ensure that all fibers in a connector are functioning. In the photos below we can see a properly functioning connector on the right where all fibers are lit; on the left is a faulty connector where one of the fiber pairs is dark.
